## **Report of Investigation**

### **Performance of Upham Beach T-Groin Installation**

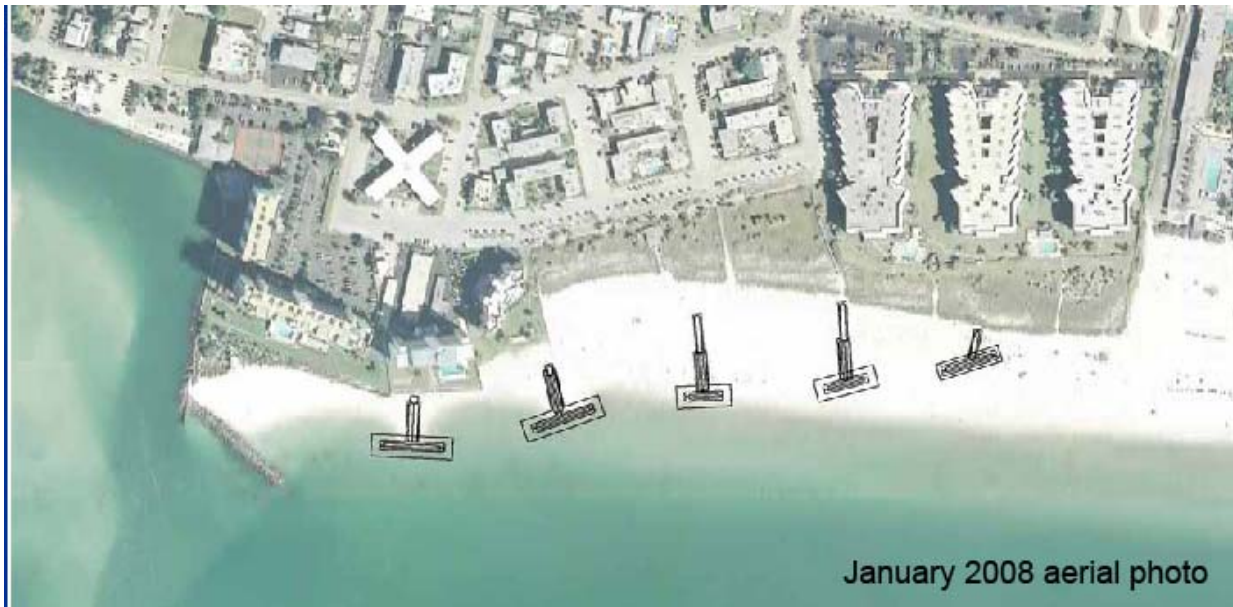
**Figure 3** – Aerial photo of groin field in January 2008. Groins T4 and T5 remain buried. Groin T3 is partially exposed to coastal processes. Modified from Elko 2009 “Stakeholders2 060109” PowerPoint presentation”.
